**HISTORIC RESOURCES INVENTORY**  
**BUILDING AND STRUCTURES**

STATE OF CONNECTICUT  
**CONNECTICUT HISTORICAL COMMISSION**  
 59 SOUTH PROSPECT STREET, HARTFORD, CONNECTICUT 06106  
 (203) 566-3005

IDENTIFICATION	1. BUILDING NAME (Common) <span style="float: right;">(Historic)</span>		Frederick J. Jourdan House		
	2. TOWN CITY		VILLAGE	COUNTY	
	Branford			New Haven

3. STREET AND NUMBER (and/or location)				
	84 Maple Street				
	4. OWNER(S)				
	Peter A. Capetta <span style="float: right;"><input type="checkbox"/> Public <input checked="" type="checkbox"/> Private</span>

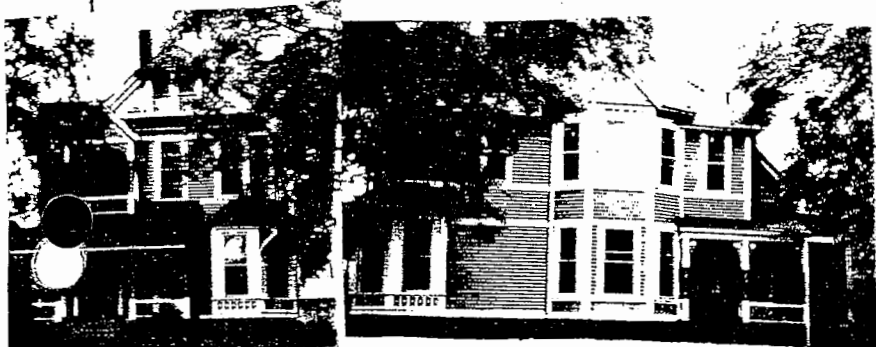
7. PHOTOGRAPH Branf. 60

House stands on south side of Maple Street facing north, on southeast corner of junction of Maple Street and Harbor Street.

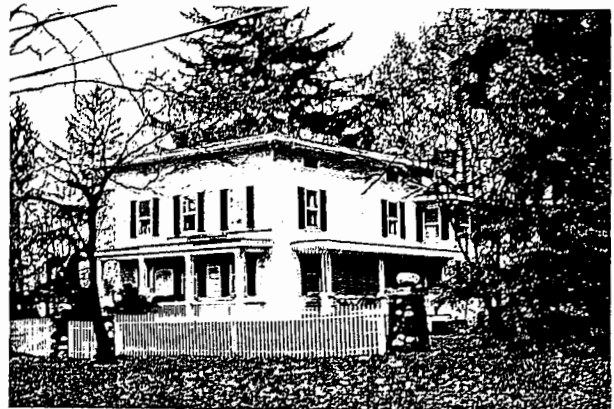
This house is vacant and being allowed to deteriorate. Paint is peeling, windows are broken, all is growing up around it.

It has the almost flat roof typical of its style and a frieze beneath. A porch runs on two sides, but they are separate. There is nothing very outstanding about it, but it could be a very nice property if repaired. A magnificent carriage house stands across the street. It is almost double size, with 2 cupolas on top.

5. PHYSICAL CONDITION OF STRUCTURE - Endangered  Yes Interior  Not Seen Exterior  Poor

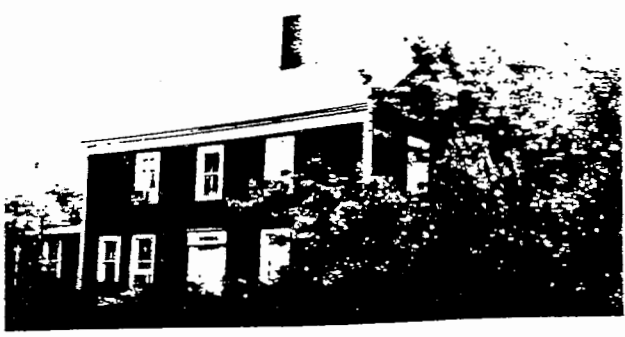
7. PHOTOGRAPH Branf. 25

House stands on northwest side of North Branford Road, Route 139, facing east, about ¼ mile north of junction with Route 1.

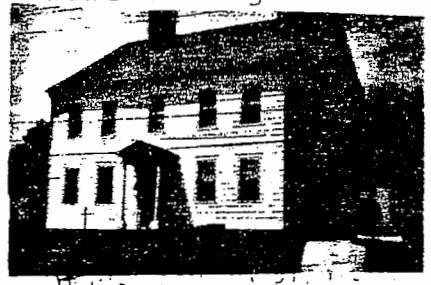
The house is entirely covered with shingles. There are several small one-story additions on both sides. Roof is covered with green composition shingles. Foundation cannot be seen. In its present condition it is not distinguished. It may, however, contain enough of the original fabric to merit restoration. It sits on a bank close to quite a busy road. There are many curves and the speeding problem is acute, according to a New Haven County sheriff who lives next door. If the road were straightened or widened, the house could be endangered.

URE - Endangered<sup>no</sup> Interior ns. Exterior fair

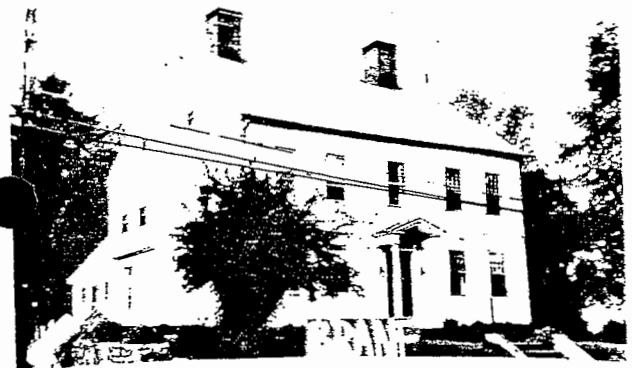
7. PHOTOGRAPH Branf. 19

<p>4. NOTABLE FEATURES, HISTORICAL SIGNIFICANCE AND DESCRIPTION</p> <p>House is not now distinguished. Stands close to road across from dairy farm and another old house in poor condition. (Baldwin house).</p>	<p>OPEN TO PUBLIC</p>
--	-----------------------

<p>5. PHYSICAL CONDITION OF STRUCTURE      Endangered    No Interior ?    Exterior Fair</p> <p>100 N. Branford Rd.</p>
--

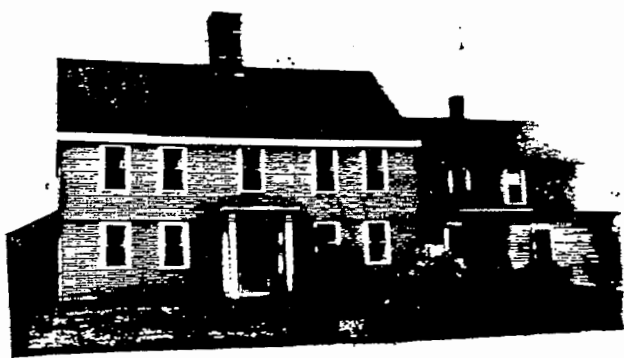
7. PHOTOGRAPH Branf 4

House stands on southeast side of North Branford R., Rt. 139, Facing northeast. It sits very close to a very busy road. It is surrounded by farm lands and the occupants raise horses.

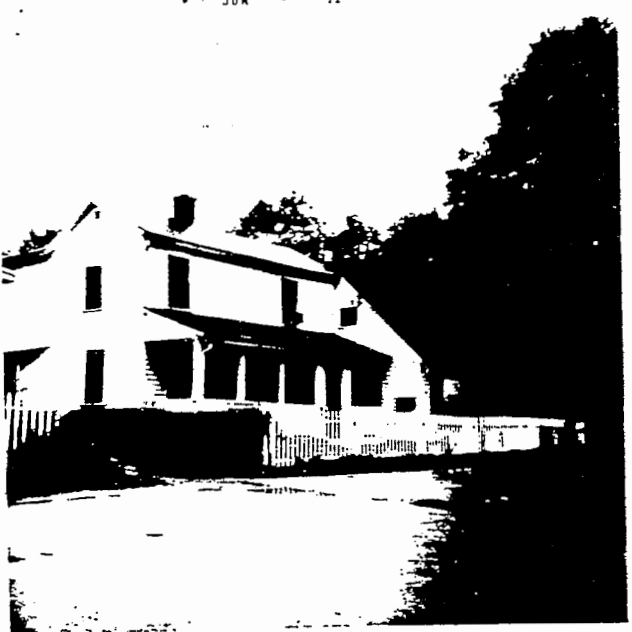
7. PHOTOGRAPH Branf. 57

Small ell at rear of Cape.

5. PHYSICAL CONDITION OF STRUCTURE - Endangered No Interior Not Seen Exterior Fair

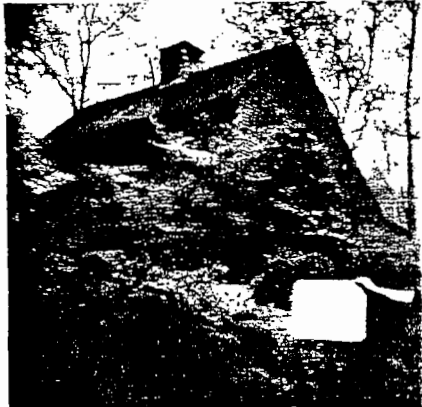
Interior well restored. Lovely setting.  
 House was moved from Madison where it was known as a "Norton House".

5. PHYSICAL CONDITION OF STRUCTURE Endangered No Interior Exc. Exterior Exc.

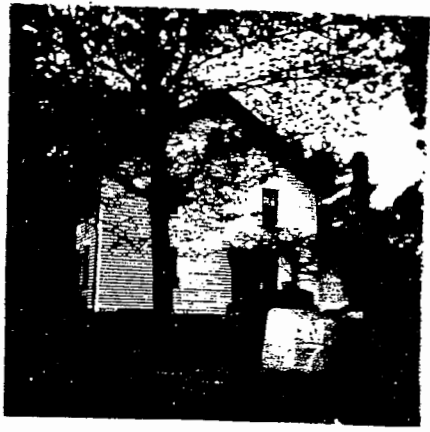
Attractive interior - 3 fireplaces of good proportion. There is impressive ornate carving on mantel piece in dining-room which is repeated on wainscoting around room in a manner hitherto not seen.

*6/29/72*  
*2/2 5051*  
*Founding*  
*stone foundation*  
*late 18th c. work*  
*exterior walls*  
*did not go inside*  
*E. Z. Baird*

5. PHYSICAL CONDITION OF STRUCTURE

Endangered ? Interior good Exterior fair

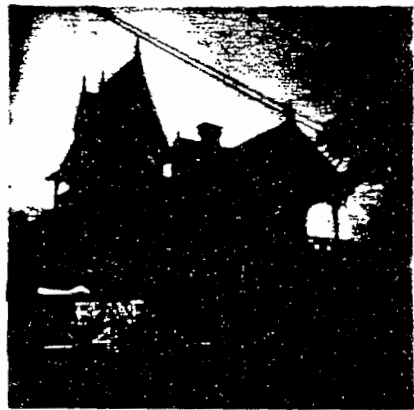
House stands on bluff overlooking harbor and Thimble Islands.  
 Many Victorian aspects - gables, turrets, porches, fine barn.  
 In area of other amusing Victorian summer houses.

5. PHYSICAL CONDITION OF STRUCTURE Endangered No Interior exc. Exterior exc.

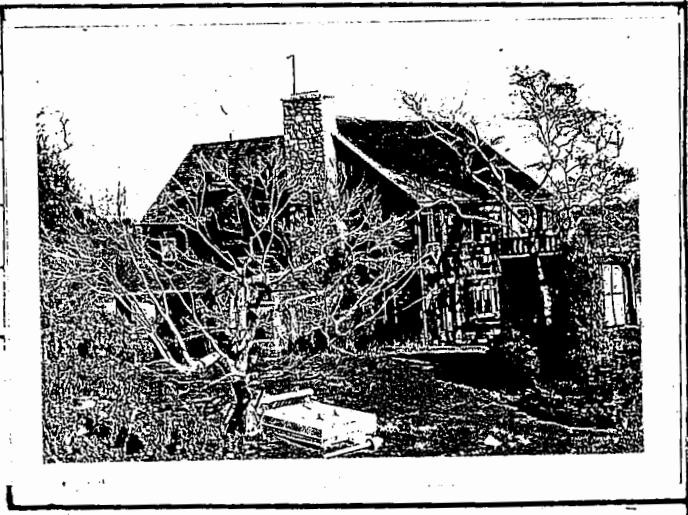
PHOTO	PHOTOGRAPHER	DATE
	Jane P. Bouley	11/25/85
COMPILED BY	VIEW	NEGATIVE ON FILE
	South & West Elevations	CHC-File 33 Neg 24
COMPILED BY	NAME	DATE
	S. Ardis Abbott & Robert B. Hurd	May, 1986
	ORGANIZATION	Architectural Preservation Trust of Branford, Inc.
ADDRESS		226 East Main St. Branford, Ct 06405

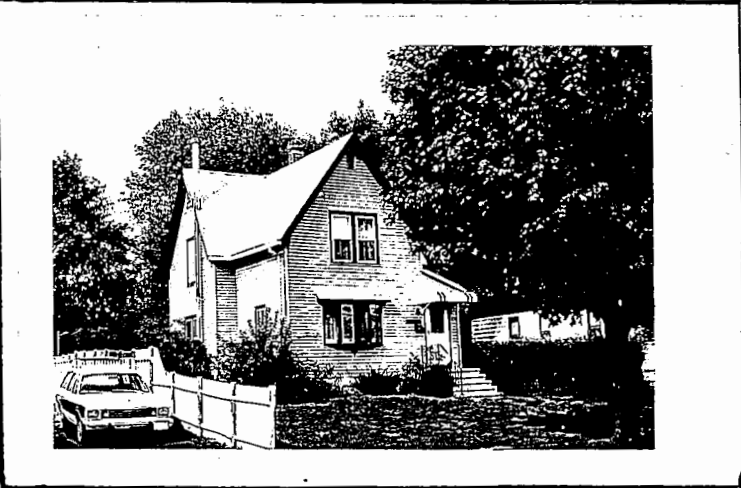
PHOTOGRAPHER	DATE
Jane P. Bouley	Oct. 1984
VIEW	NEGATIVE ON FILE
South Elevation	CHC-File 9 Neg 4
NAME	DATE
S. Ardis Abbott & Robert B. Hurd	3/85
ORGANIZATION	
Architectural Preservation Trust of Branford, Inc.	
ADDRESS	
226 East Main Street, Branford, CT 06405

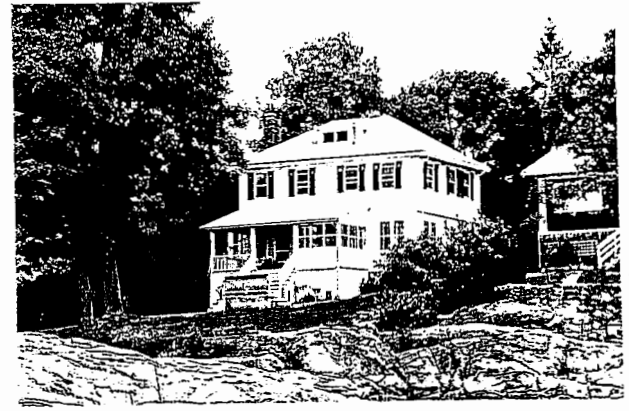
PHOTOGRAPHER	DATE
Jane P. Bouley	9/17/85
VIEW	NEGATIVE ON FILE
South & East Elevations	CHC-File 23 Neg 5
NAME	DATE
S. Ardis Abbott & Robert B. Hurd	May, 1986
ORGANIZATION	
Architectural Preservation Trust of Branford, Inc.	
ADDRESS	
226 East Main St. Branford, Ct 06405

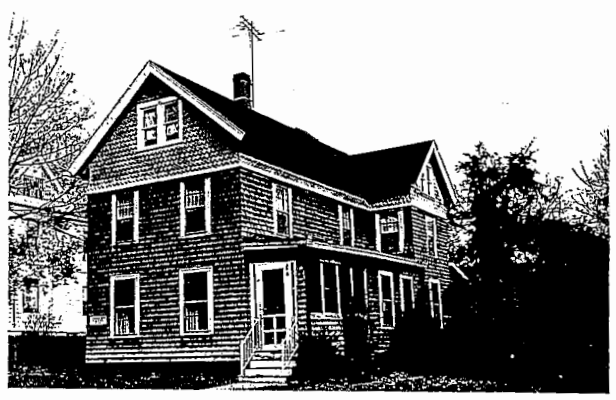
PHOTO	PHOTOGRAPHER		DATE
	Jane P. Bouley		Nov., 1984
COMPILED BY	VIEW	NEGATIVE ON FILE	
	West & South Elevs.	CHC-File 14 Neg 18	
	NAME		DATE
	S. Ardis Abbott & Robert B. Hurd		4/85
	ORGANIZATION		
Architectural Preservation Trust of Branford, Inc.			
ADDRESS			
226 East Main Street, Branford, CT 06405

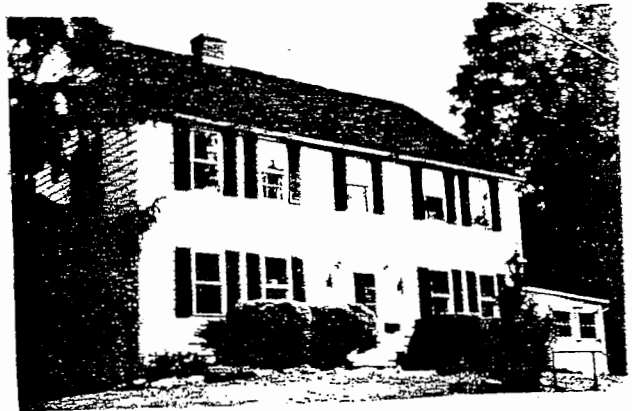
7. PHOTOGRAPH Branf 63

5. PHYSICAL CONDITION OF STRUCTURE - Endangered No Interior n.s. Exterior fair

House stands on north side of Sachem Road facing south.

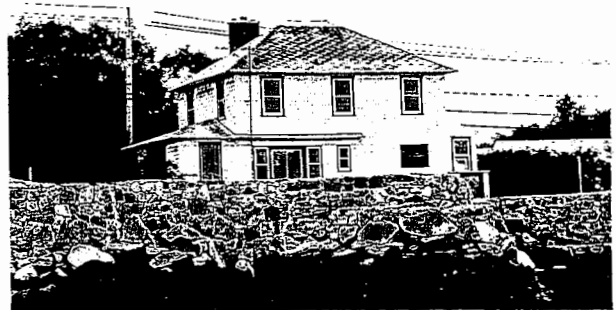
PHOTO	PHOTOGRAPHER	DATE
	Jane P. Bouley	9/17/85
VIEW	South & West Elevations	NEGATIVE ON FILE CHC-File 24 Neg 23
	NAME	DATE
COMPILED BY	S. Ardis Abbott & Robert B. Hurd	May, 1986
	ORGANIZATION	Architectural Preservation Trust of Branford, Inc.
	ADDRESS	226 East Main St. Branford, Ct 06405

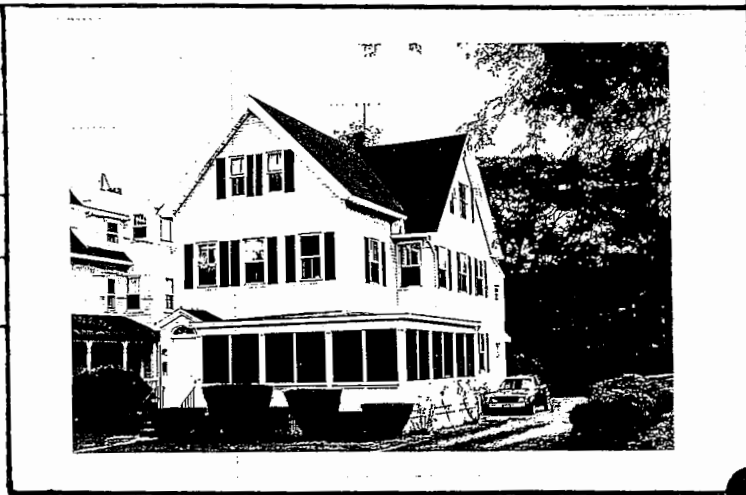
Constructed on a cruciform plan with its ridge perpendicular to the street and a cross gable facing east, this structure has a steeply pitched roof with decorated gable rakes and large S-shaped brackets at the gable overhangs. A large shed dormer has replaced the west-facing gable. Scalloped shingles decorate the gables at the attic story and smooth trim boards belt the building at the second story window sills. Its windows have two-over-two sash; its paneled entry door has a large glass light. Its veranda features a spool frieze, turned posts with scroll-sawn brackets and a turned balustrade

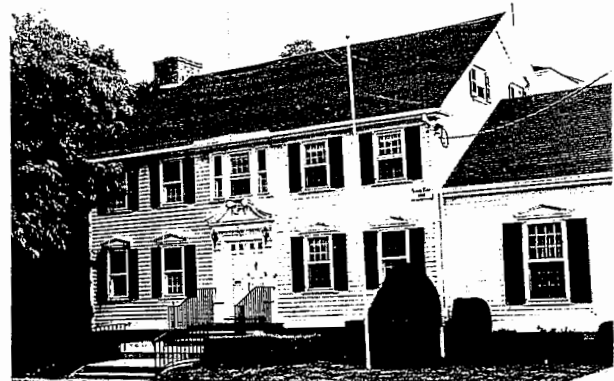
Constructed on a rectangular plan with its ridge parallel to the street, this structure has a steeply pitched roof with cornice returns. It has a five-bay, nine-window facade with large double-door entry. Its twelve-over-twelve windows have pediments at the first floor and projecting cornices at the second floor. Its entry doors are flanked by pilasters and crowned by a broken pediment. Its original center chimney has been removed and replaced by an exterior chimney on the east elevation. Its west end features a 1974 addition, one-and-one half stories high, which obscures the building's original features.

PHOTOGRAPHER Jane P. Bouley	DATE Sept., 1984
VIEW North Elevation	NEGATIVE ON FILE CHC-File 8 Neg 15A
NAME S. Ardis Abbott & Robert B. Hurd	DATE 4/85
ORGANIZATION Architectural Preservation Trust of Branford, Inc.	
ADDRESS 226 East Main Street, Branford, CT 06405

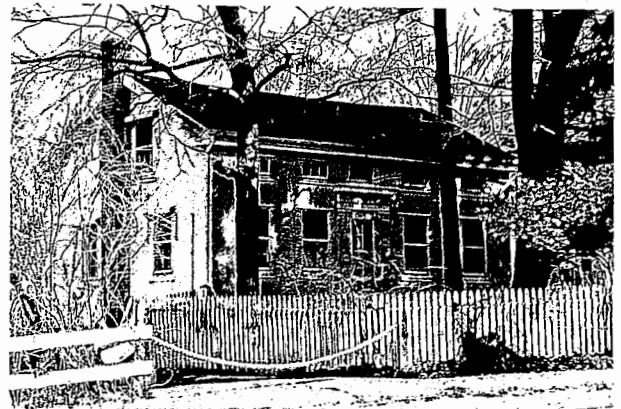
PHOTO	PHOTOGRAPHER	DATE
	Jane P. Bouley	3/18/86
COMPILED BY	VIEW	NEGATIVE ON FILE
	South & West Elevations	CHC-File 43 Neg 22
	NAME	DATE
	S. Ardis Abbott & Robert B. Hurd	May, 1986
	ORGANIZATION	
	Architectural Preservation Trust of Branford, Inc.	
	ADDRESS	
	226 East Main St. Branford, Ct 06405

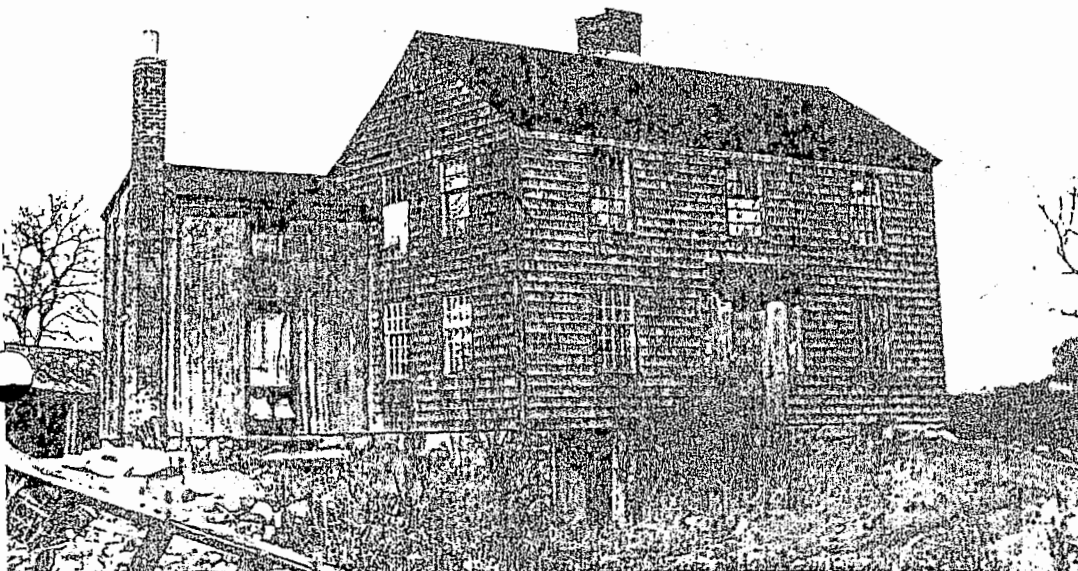
Door Way  
 Fragment, square top  
 Greek Revival door-  
 way with narrow double  
 hung window sidelights

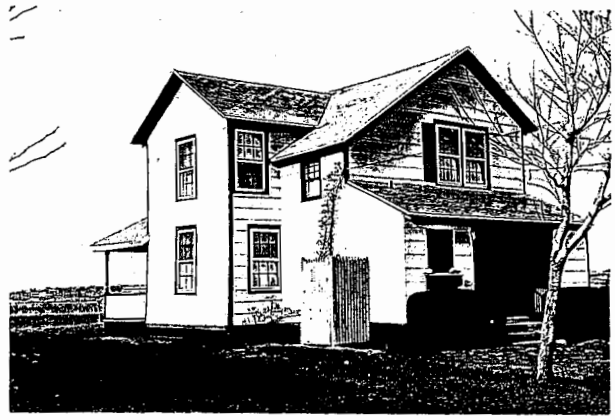
PHOTOGRAPHER	Jane P. Bouley	DATE	11/25/85
VIEW	East & South Elevations	NEGATIVE ON FILE	CHC-File 33 Neg 4
NAME	S. Ardis Abbott & Robert B. Hurd	DATE	May, 1986
ORGANIZATION	Architectural Preservation Trust of Branford, Inc.		
ADDRESS	226 East Main St. Branford, Ct 06405

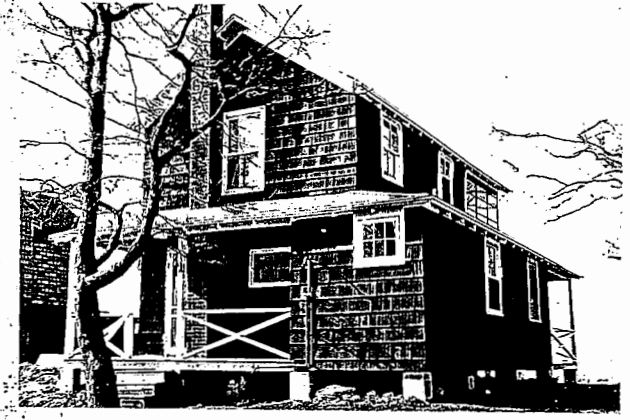
Constructed on an L-shaped plan with its primary ridge perpendicular to the street, this structure has a shallow-pitched roof with minimal overhangs at the eaves and gables. Windows appear to be replacements. Its veranda was covered for the winter and not visible during the field survey.

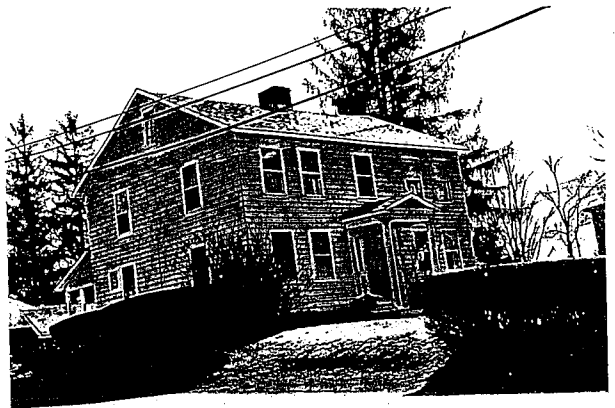
DESCRIPTION (Continued)	<p>17 OTHER NOTABLE FEATURES OF BUILDING OR SITE (interior and/or exterior)</p> <p>Constructed on a rectangular plan with its ridge parallel to the facade, this structure has a shallow-pitched roof with overhangs at the cornice and the gables. Its brick center chimney straddles the ridge. It has a nine-window facade and a five-window gable. Windows are one-over-one replacements. Its center entry is flanked by three-light sidelights and a pair of Doric pilasters and is protected by a small portico featuring a triangular pediment with a smooth frieze and round Doric posts.</p>	
	<p>18 ARCHITECT</p> <p>Unknown</p>	<p>BUILDER</p> <p>Unknown</p>
SIGNIFICANCE	<p>19 HISTORICAL OR ARCHITECTURAL IMPORTANCE</p> <p>This house is recorded in the W.P.A. survey and dated 1839 from a marker on the house. The house was probably built by John A. Wilford who transferred it to his son Samuel in 1842.</p> <p>The John A. Wilford Homestead is one of the oldest houses in the Indian Neck area and is historically associated with an early Branford family and the development of the Indian Neck section in the first half of the nineteenth century.</p>

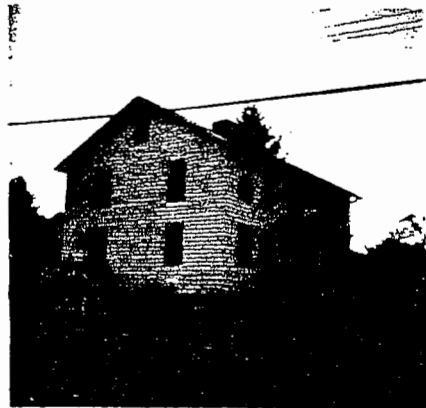
14-13

Gable end to street. Nondescript, in commercial area.

5. PHYSICAL CONDITION OF STRUCTURE Endangered ? Interior ? Exterior Good

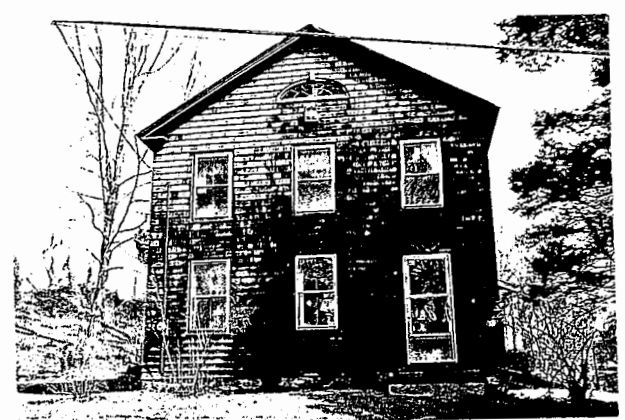
Constructed on a rectangular plan with its ridge perpendicular to the street, this structure has a shallow-pitched roof with overhangs at the cornices and gables and cornice returns. The gable features a semi-circular fan light at the attic story. Its facade has five windows arranged in three bays. Windows have two-over-two sash. Its entry features Doric pilasters supporting a three-part entablature with a projecting cornice and a frieze decorated with a triglyph motif. As noted on the opposite side, cornice returns are a remnant of a full cornice shown in the photograph taken for the WPA survey.

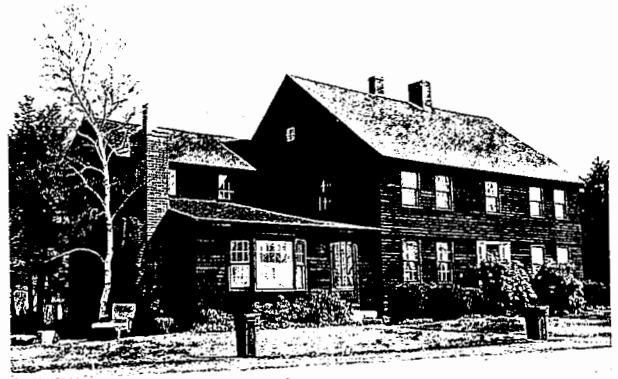
Constructed on a rectangular plan with its ridge parallel to the street, this structure has a steeply pitched roof with a boxed cornice at the facade. Hewn overhangs occur at both the second and attic floors. Its chimneys appear too small to be original. Its facade has nine windows; its gables have (had) five windows. Windows appear to be replacements. Its center entry is flanked by Doric pilasters, but the entablature shown in earlier State and WPA survey photos has been removed. The two-story ell at the west end is shown in another early photo with an open porch, since replaced by the addition visible in the photograph. Another ell is located at the northeast corner in the rear.

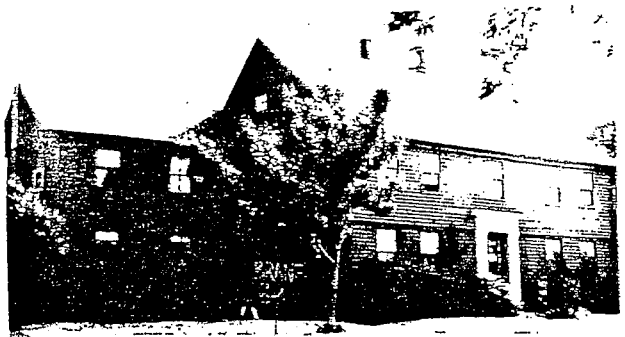
**7. PHOTOGRAPH** Branf. #22

Foundation cannot be clearly seen.

**5. PHYSICAL CONDITION OF STRUCTURE** - Endangered ? Interior Fair Exterior Fair

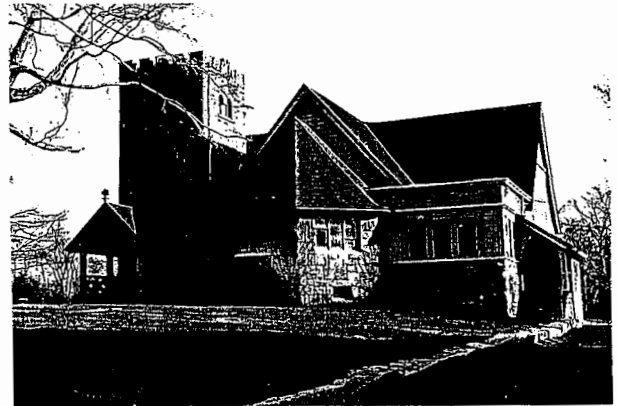
This Church of Christ at Stony Creek was built in 1901. It replaced a former chapel built in 1866 which burned June 8, 1900. The site had formerly been the Foote Hotel which burned in 1877. The lot was purchased for the Church by the Ladies Aid Society. The church was constructed of Stony Creek granite.

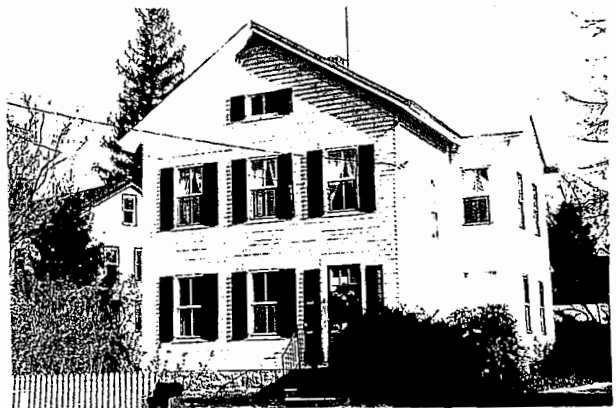
Constructed on an L-shaped plan with its primary ridge perpendicular to the street and its ell facing south, this structure has a shallow-pitched roof with wide overhangs and a smooth frieze at the eaves and gables. Its five-window facade retains early two-over-two sash. Its entry door appears to be a replacement.

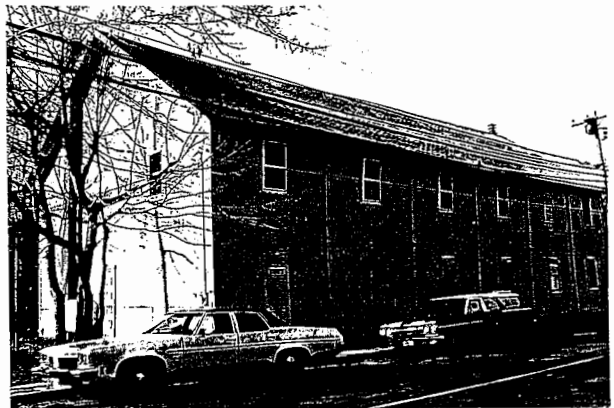
Constructed on a rectangular plan with its ridge parallel to the street, this structure has a steeply pitched roof with wide gable overhangs and exposed rafter tails at the eaves. Its street facade has six bays separated by projecting posts. Windows have six-over-six sash. Window trim projects around the head, jambs and sill at the first story windows and from the sill up the jambs to a projecting layer of siding at the second story. A wood water table skirts the building at the top of the foundation.

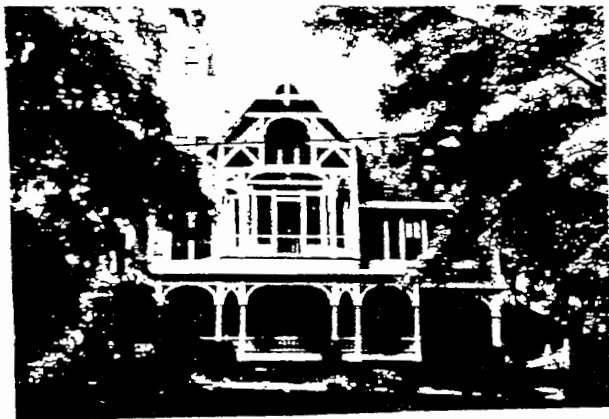
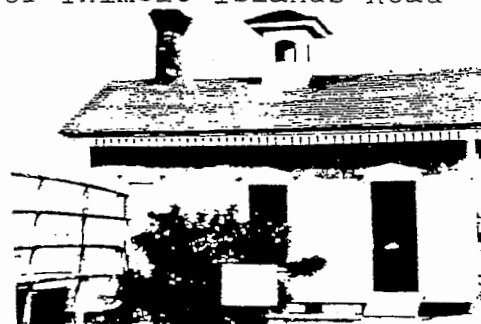
**5. PHYSICAL CONDITION OF STRUCTURE** - Endangered NO Interior Not Seen Exterior Very Good

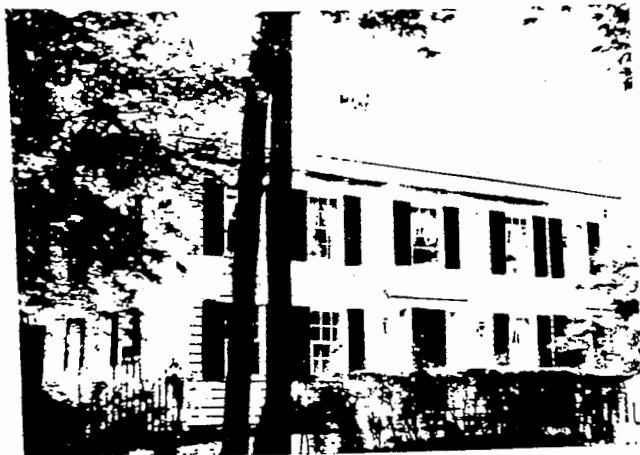
7. PHOTOGRAPH Branf. 20

5. PHYSICAL CONDITION OF STRUCTURE - Endangered No Interior Seen Exterior Good Not

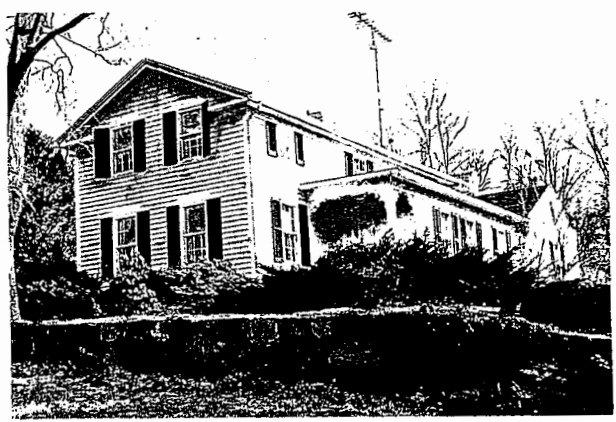
PHOTO	PHOTOGRAPHER Jane P. Bouley	DATE 3/18/86
	VIEW West Elevation	NEGATIVE ON FILE CHC-File 43 Neg 18
COMPILED BY	NAME S. Ardis Abbott & Robert B. Hurd	DATE May, 1986
	ORGANIZATION Architectural Preservation Trust of Branford, Inc.	
	ADDRESS 226 East Main St. Branford, Ct 06405

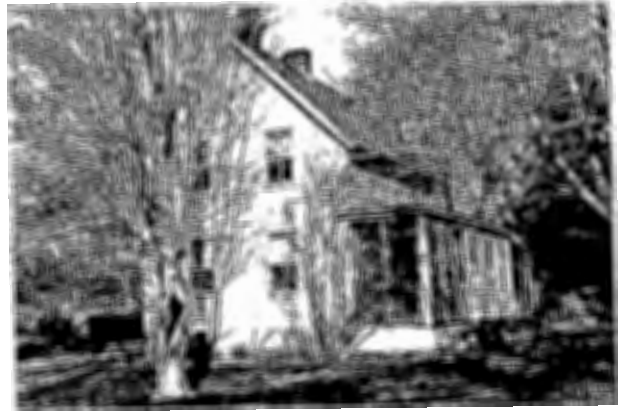
PHOTO	PHOTOGRAPHER	DATE
	Jane P. Bouley	12/16/85
COMPILED BY	VIEW	NEGATIVE OR FILE
	West Elevation	CHC-File 39 Neg 23
COMPILED BY	NAME	DATE
	S. Ardis Abbott & Robert B. Hurd	May, 1986
	ORGANIZATION	Architectural Preservation Trust of Branford, Inc.
	ADDRESS	
	226 East Main St. Branford, Ct 06405

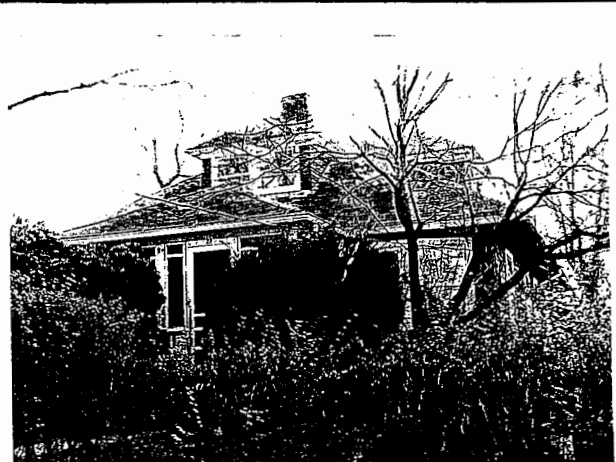
PHOTO	PHOTOGRAPHER	DATE
	Jane P. Bouley	1/6/86
VIEW	NEGATIVE ON FILE	
	East Elevation	CHC-File 40 Neg 2
COMPILED BY	NAME	DATE
	S. Ardis Abbott & Robert B. Hurd	May, 1986
	ORGANIZATION	
	Architectural Preservation Trust of Branford, Inc.	
ADDRESS	226 East Main St. Branford, Ct 06405

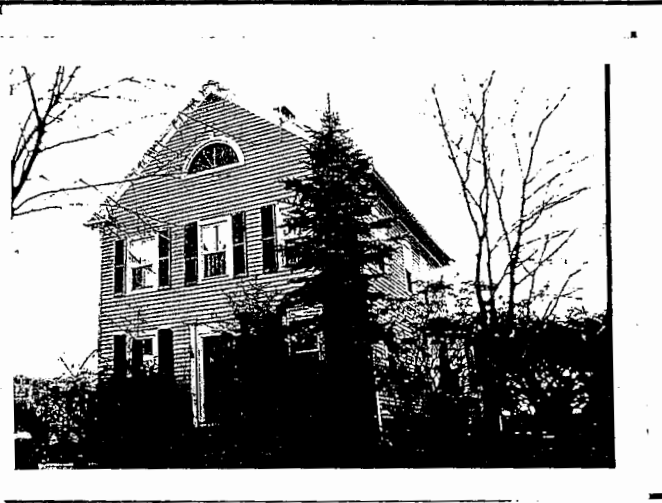
PHOTO	PHOTOGRAPHER	DATE
	Jane P. Bouley	1/6/86
VIEW	NEGATIVE ON FILE	
	East Elevation	CHC-File 40 Neg 1
COMPILED BY	NAME	DATE
	S. Ardis Abbott & Robert B. Hurd	May, 1986
	ORGANIZATION	Architectural Preservation Trust of Branford, Inc.
	ADDRESS	
	226 East Main St. Branford, Ct 06405

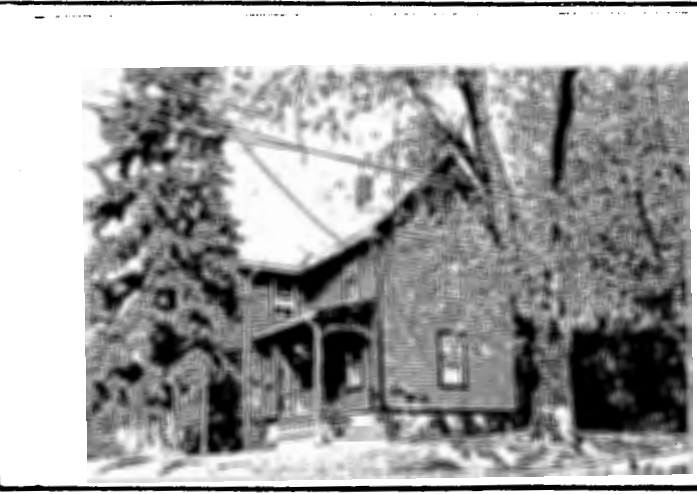
PHOTOGRAPHER	DATE
Jane P. Bouley	Oct., 1984
VIEW	NEGATIVE ON FILE
Southwest Corner	CHC-File 10Neg 12
NAME	DATE
S. Ardis Abbott & Robert B. Hurd	4/85
ORGANIZATION	
Architectural Preservation Trust of Branford, Inc.	
ADDRESS	
226 East Main Street, Branford, CT 06405
